INSPECTION REPORT

Mine Name: Bacon Rock Number: S/037/101 County: San Juan Status: Reclaimed
Operator: Bedrock Stone Company Participants: Ted McDougall (BLM) and Paul Baker
Weather conditions: Mostly clear, 30's

S/037/101, Bacon Rock Quarry, Eldon Virgil

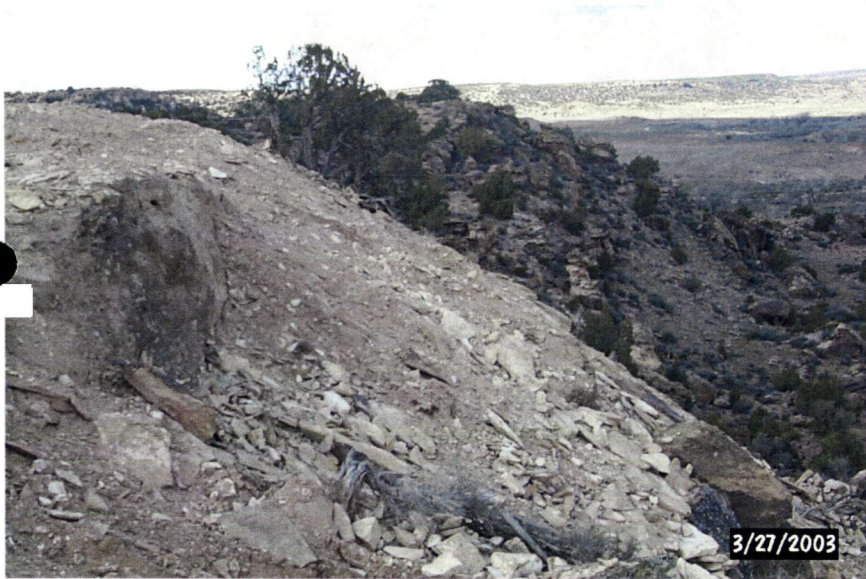
The grading matches surrounding areas very well (Photo 2). Mr. McDougall said the operator tried to pull up as much material as possible from the outslope of the quarry (Photo 1). On the east side of the quarry, the top is fairly flat with a sudden dropoff at the edge of the outslope (Photo 1). There is a possibility this could lead to erosion problems, but I don't think so because of the amount of rock in the surface. In general, I am pleased with how the site was graded.

Photo 1. The outslope from which the operator pulled material.

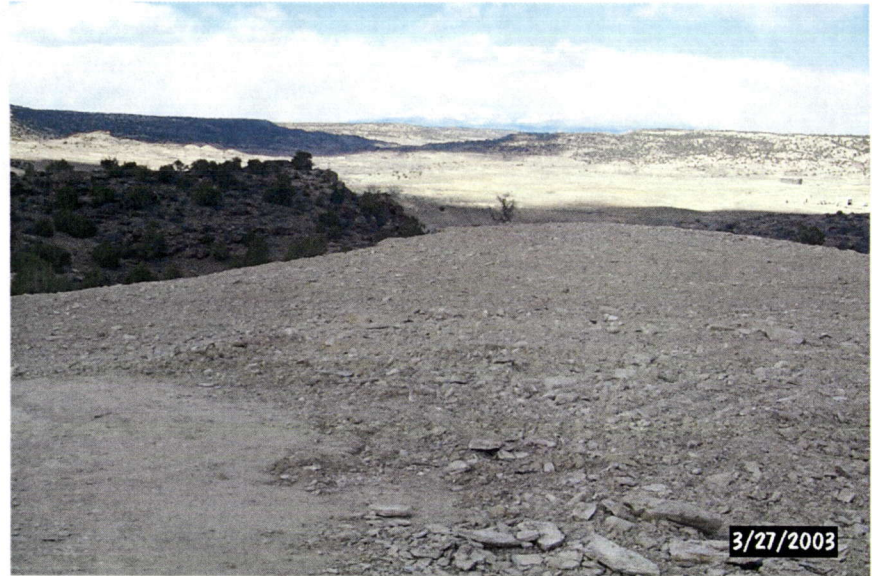
Photo 2. An overview of the regraded quarry.
